Condition when Received

Repaired & Rebuilt Dyne

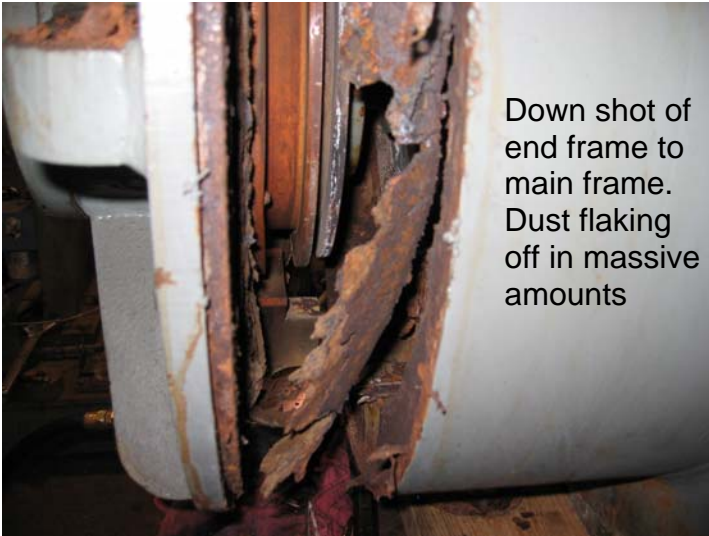
Down shot of end frame to main frame. Dust flaking off in massive amounts

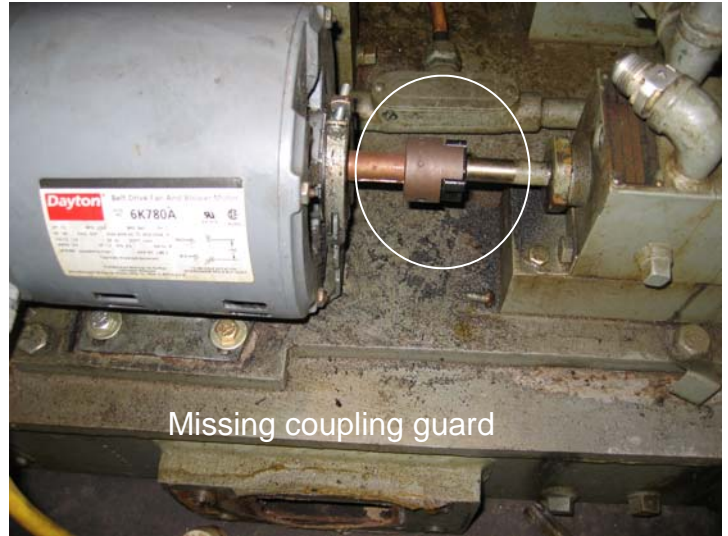
Missing coupling guard

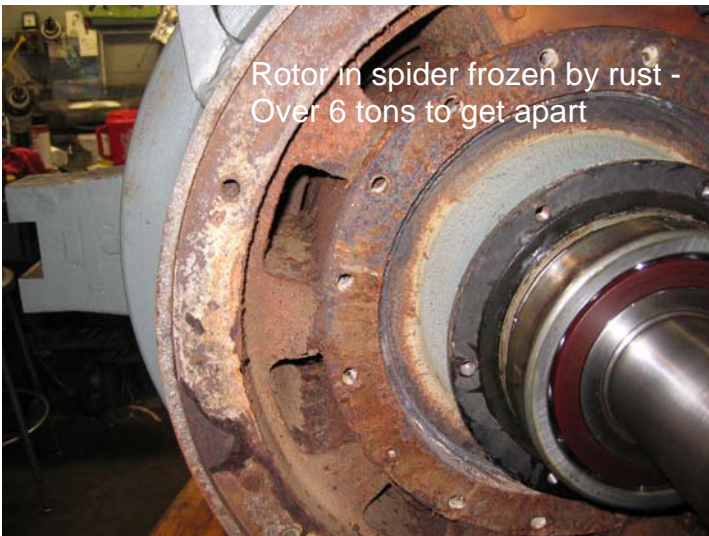
Rotor in spider frozen by rust - Over 6 tons to get apart

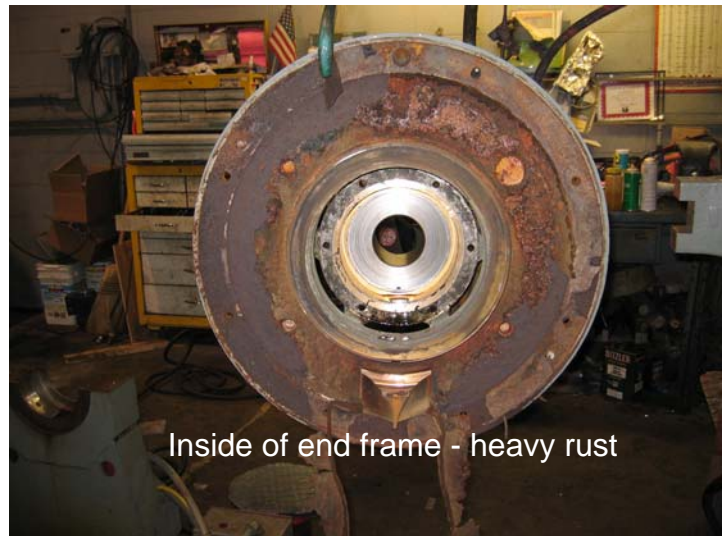
Inside of end frame - heavy rust

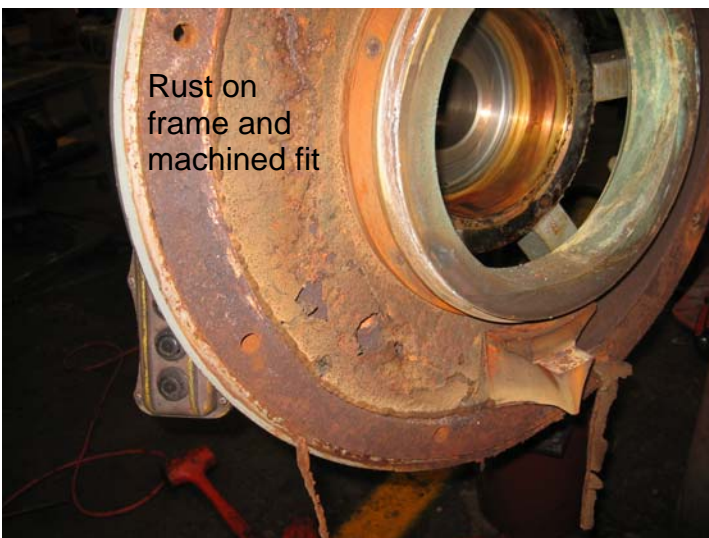
Rust on frame and machined fit

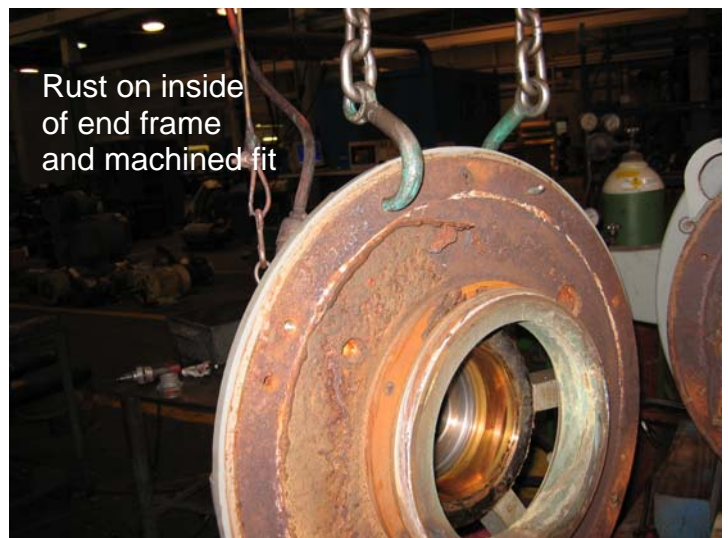
Rust on inside of end frame and machined fit

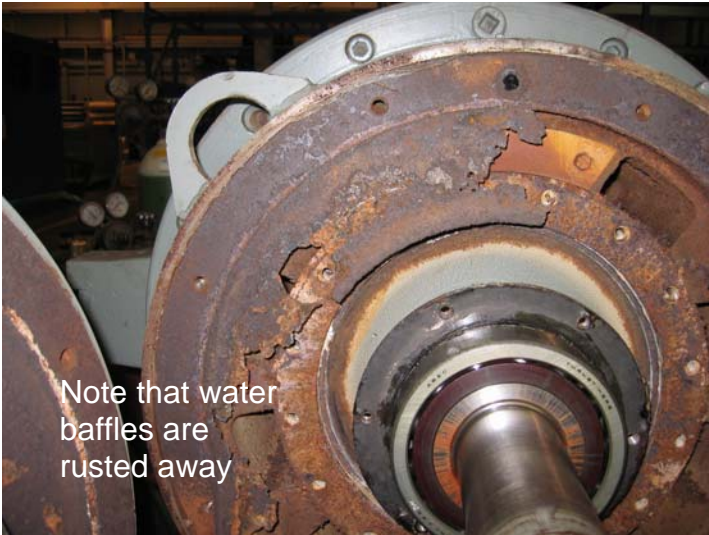
Note that water baffles are rusted away

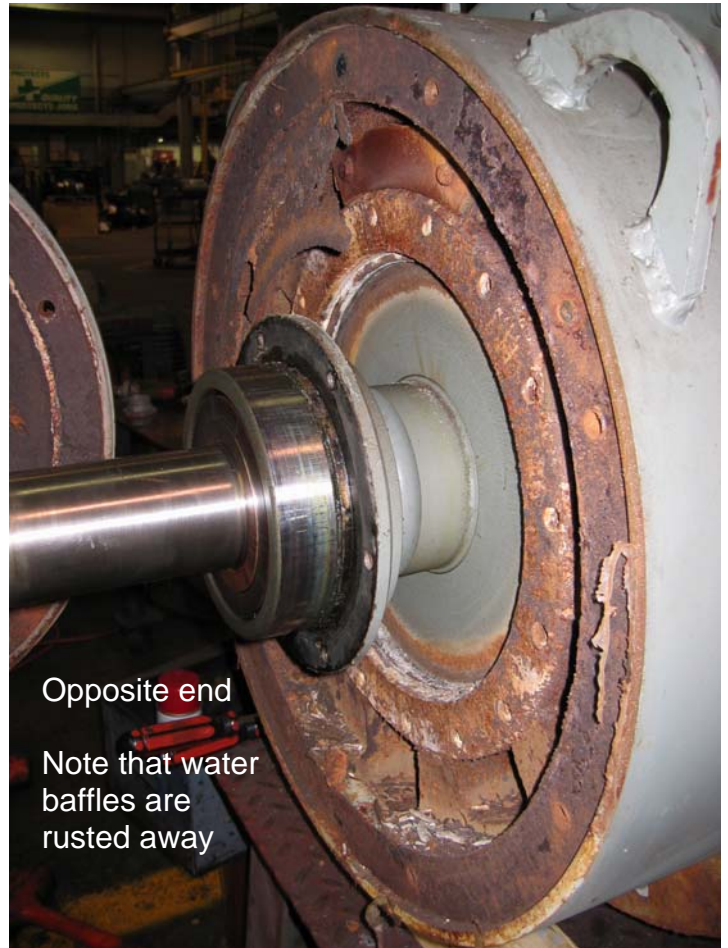
Opposite end

Note that water baffles are rusted away

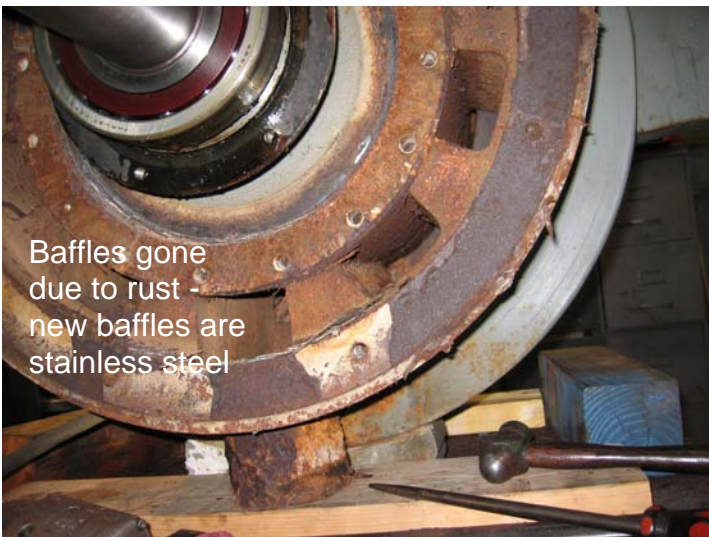
Baffles gone due to rust - new baffles are stainless steel

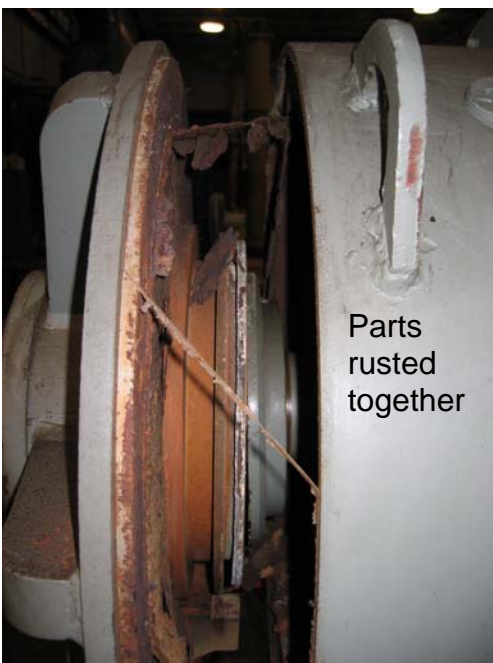
Parts rusted together

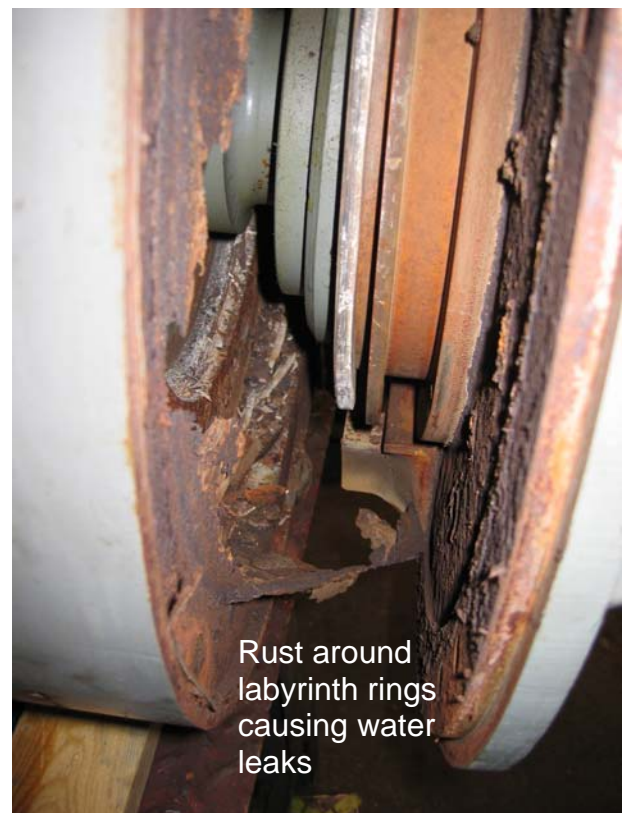
Rust around labyrinth rings causing water leaks
